Manhole Inspection Summary

Manhole # S25EE1006MH

Location Address: **1205 40TH ST**

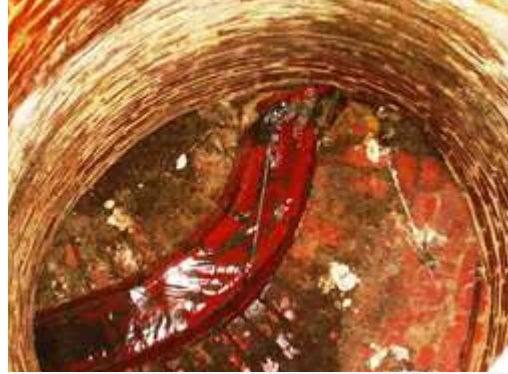
Top View

Evidence of surcharge - Bench debris.

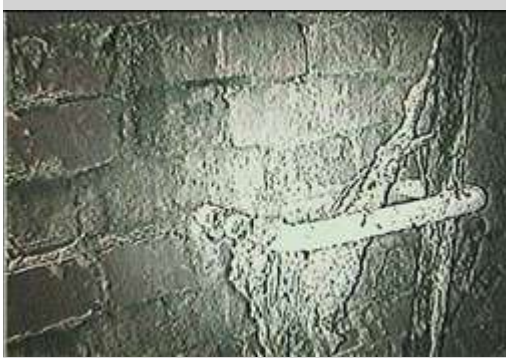
Defect

Barrel deterioration and infiltration.
Evidence of surcharge.

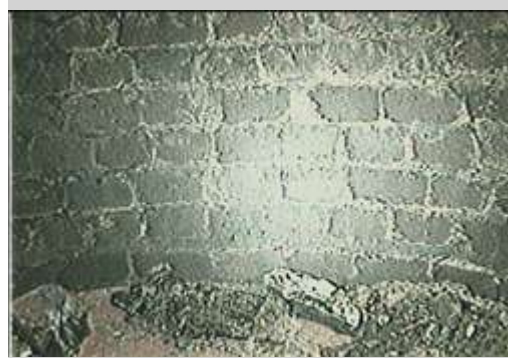
Defect

Barrel deterioration and infiltration.

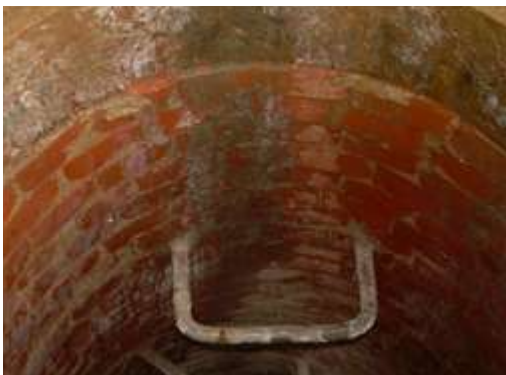
Defect

Frame leaks. Adjustment deterioration
and infiltration.

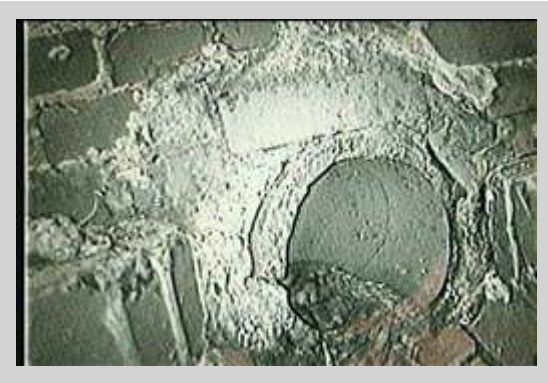
Pipe Out @ 12 O'Clock

Barrel deterioration and infiltration. Channel deterioration.

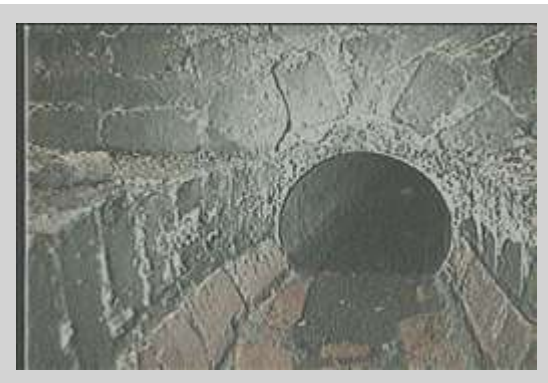
Pipe In @ 9 O'Clock

Barrel deterioration and infiltration. Channel deterioration.
